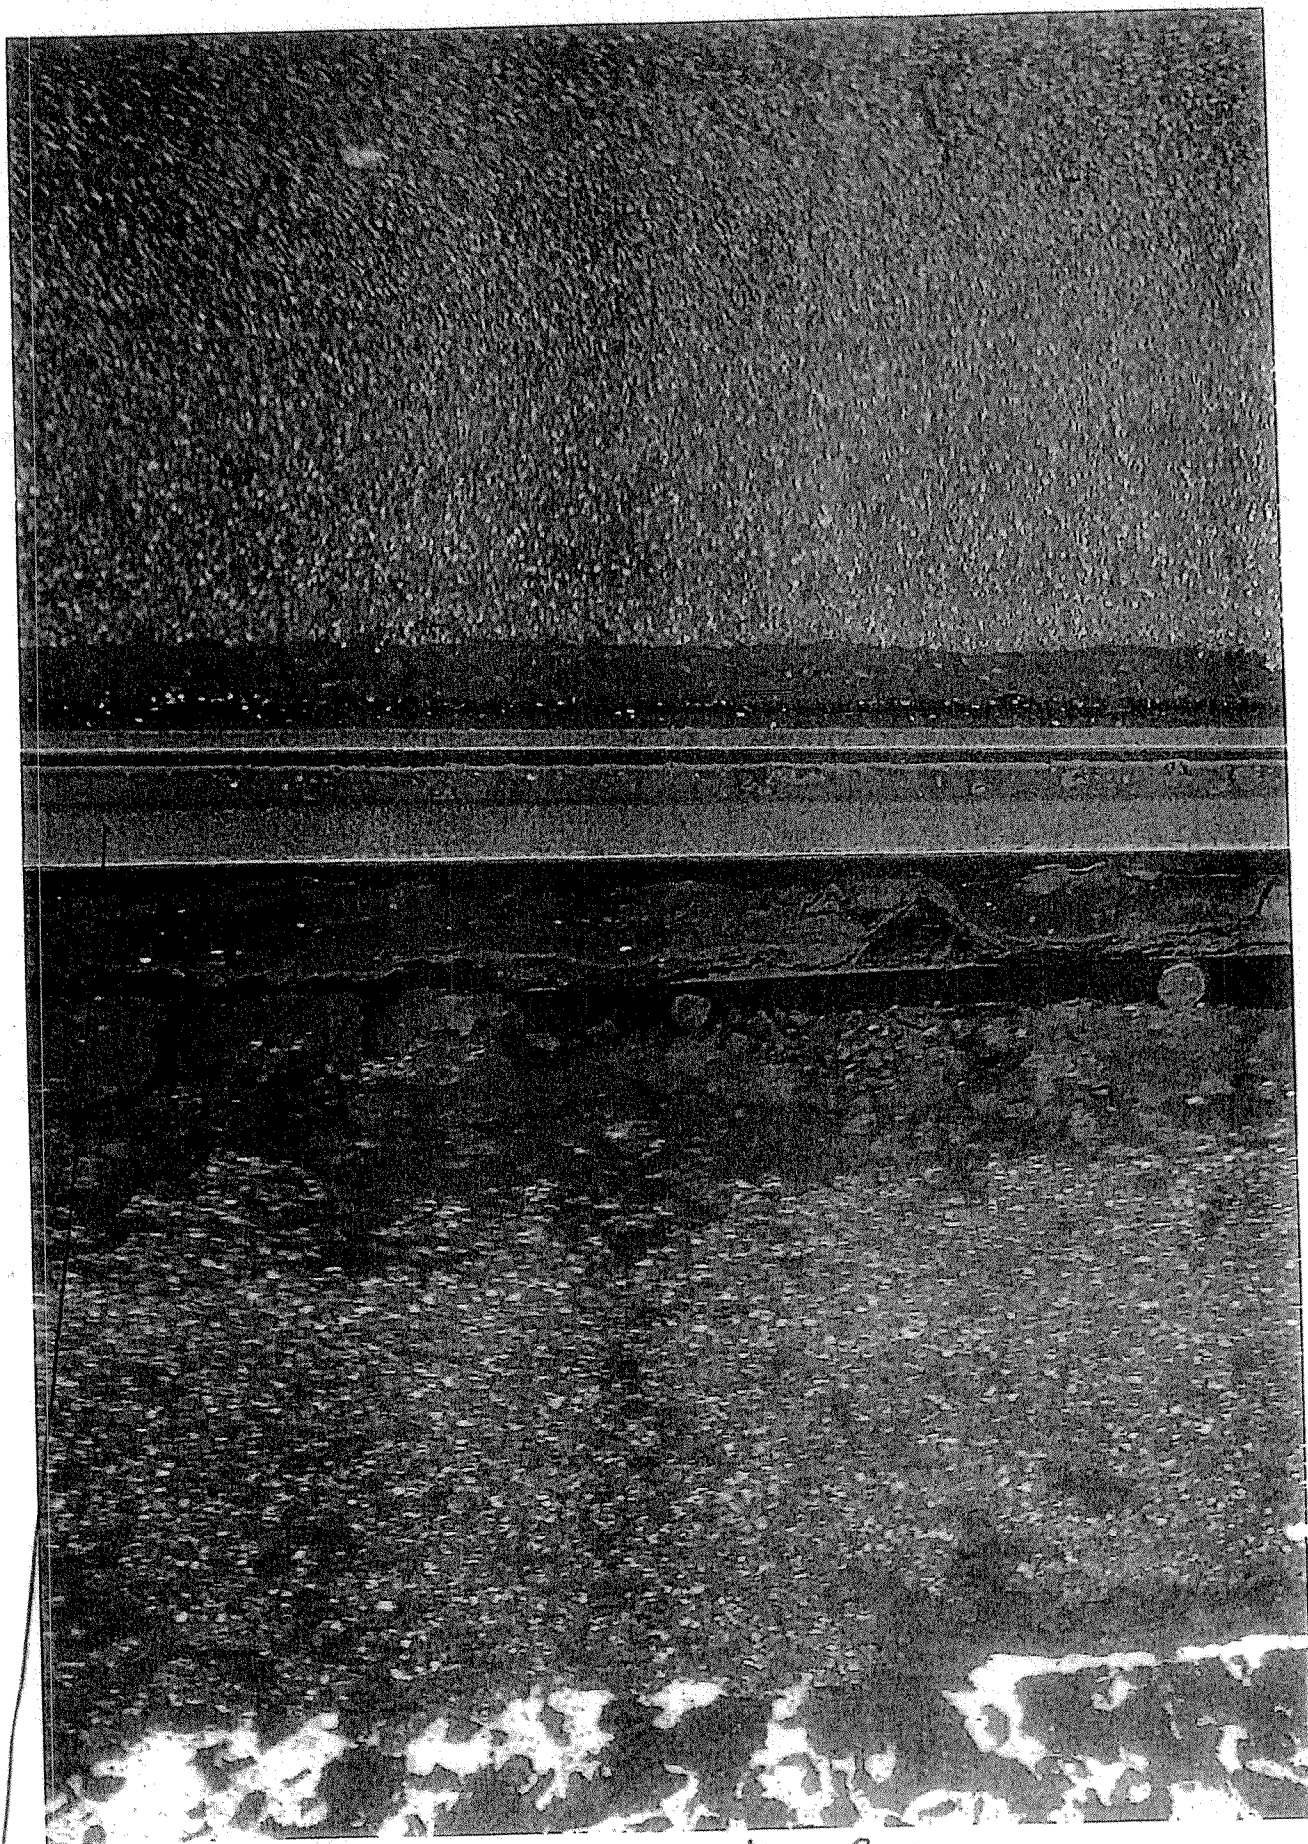
Photo 3.

FAULTS - ①. DE-BONDING OF MASTIC ROAD/RAIL BOND.  
②. CRACKING OF ASPHALT DUE TO MOVEMENT OF CHAMBER ELEMENT.  
③. CHAMBER ELEMENT MOVING UNDER LOAD.

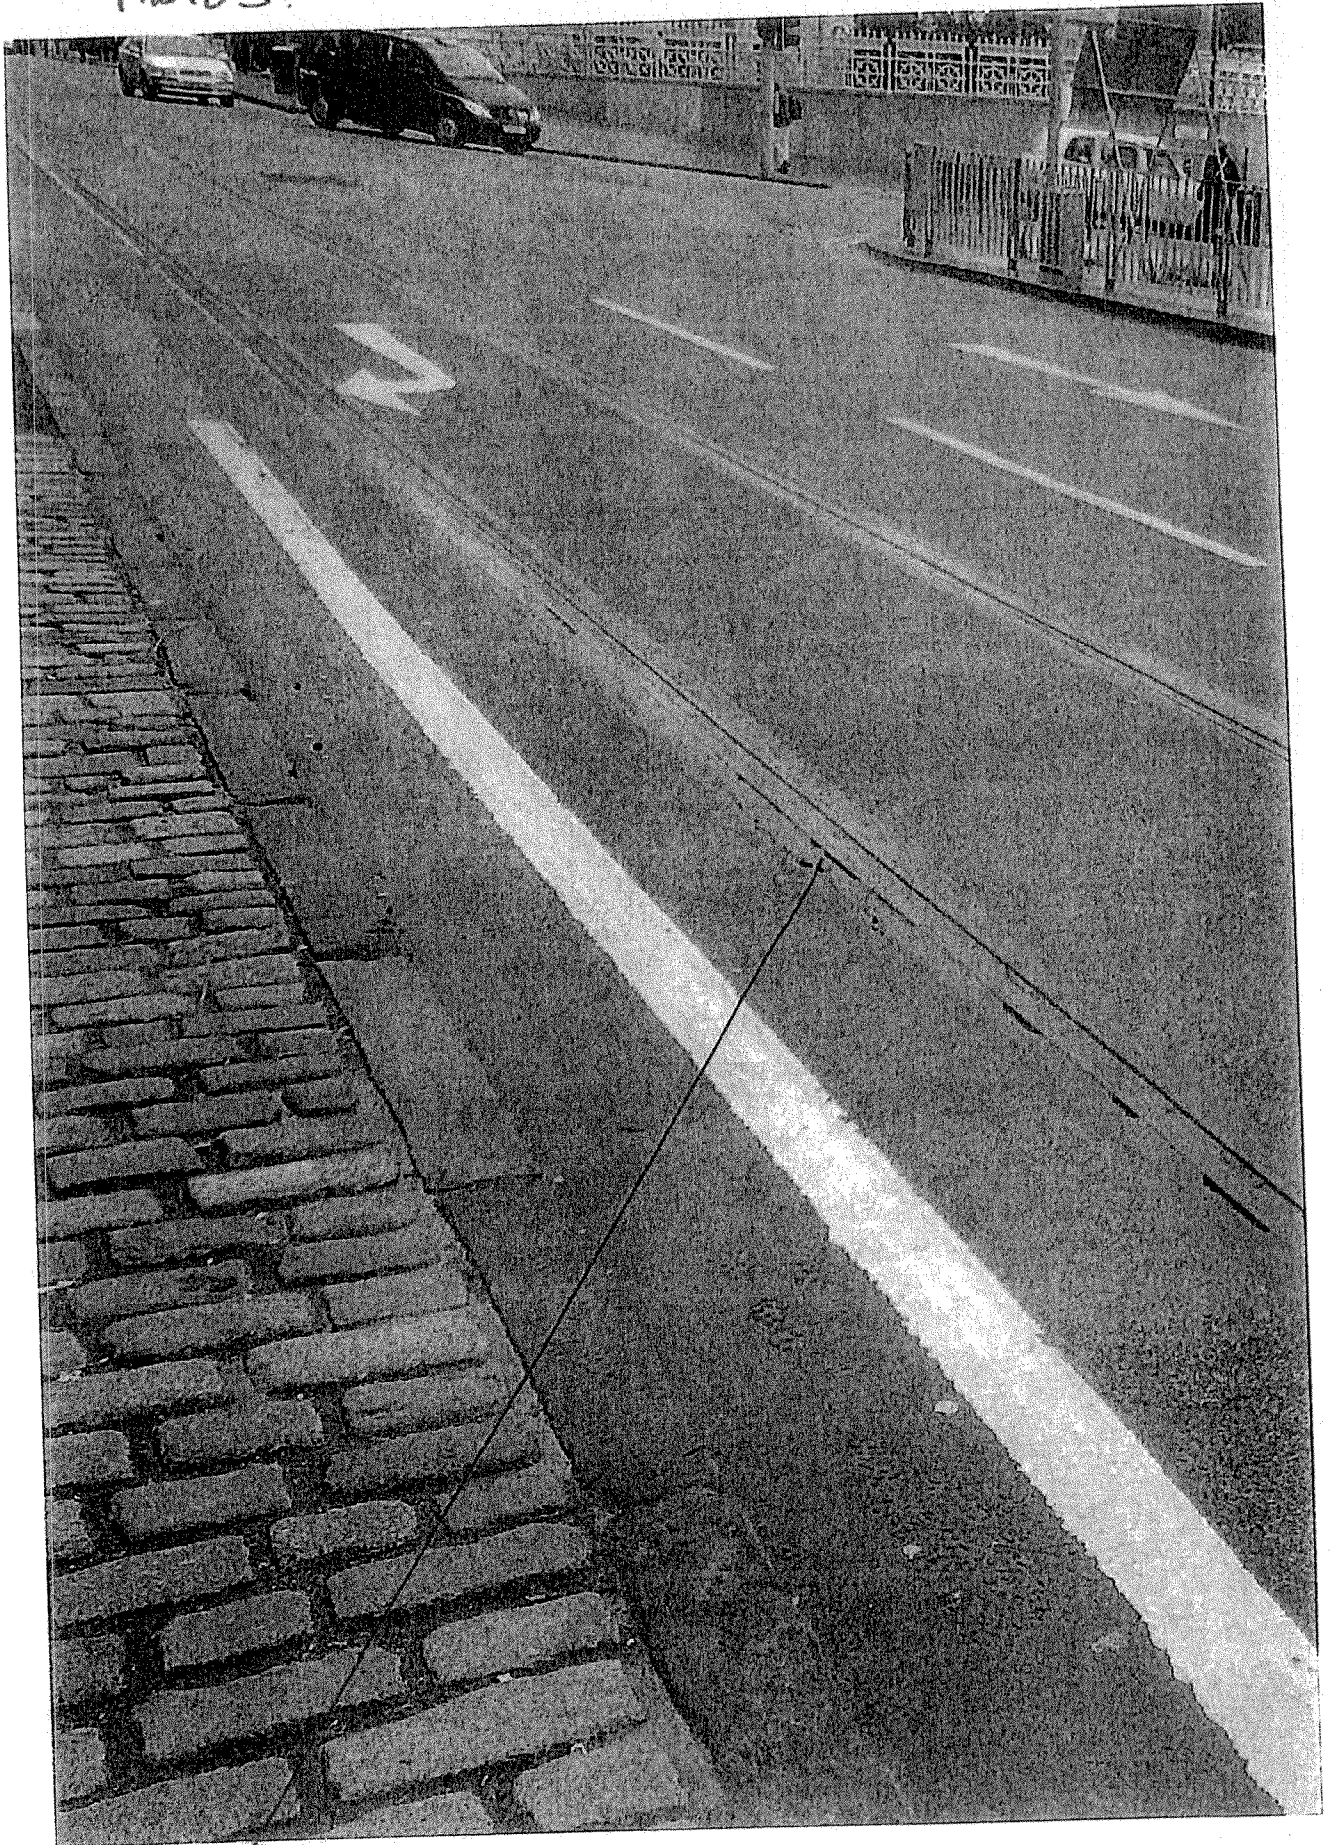
PHOTO 5.

FAULT. - LOCATED DE-BONDING OF ASPHALT JOINT BETWEEN  
ROAD/PAV. I SUSPECT POOR QUANTITY CONTROL DURING  
INSTALLATION.

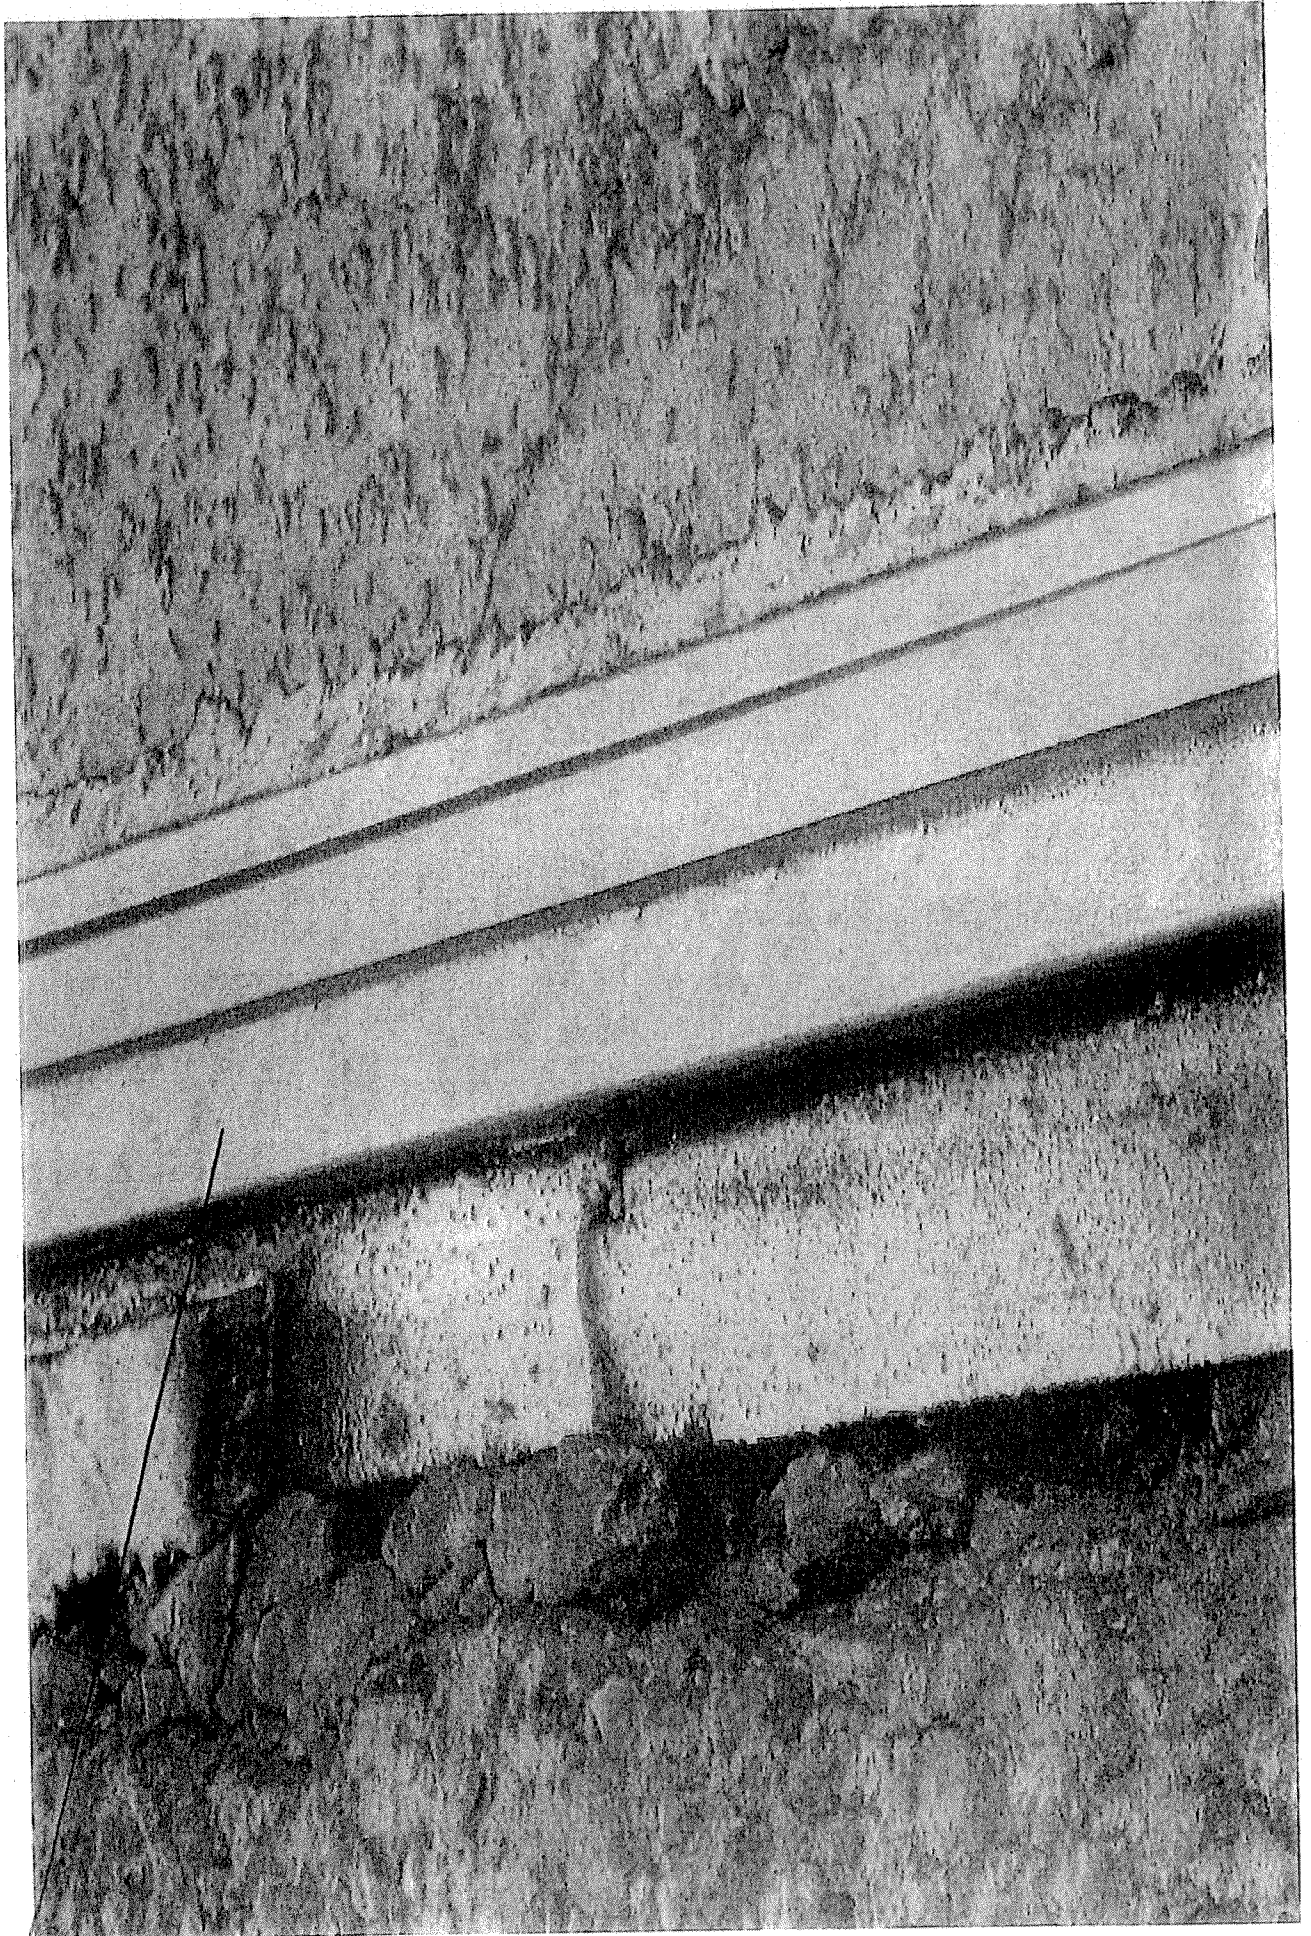
PHOTO 7.

FAULT AFTER REMEDIATION - MOVEMENT IN THE OUTER CHAMBER & DEFORMATION
